**People v William CADY**

**SCD No.253340 / DA No. ADP185**

**COLLISION: JUNE 09, 2012 2:58 A.M.**

**MT ACADIA BOULEVARD WEST OF SNEAD AVE.**

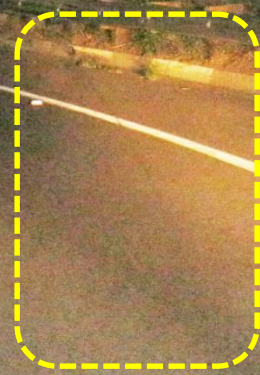
Left side tire(s)

Right Side Tire(s)

SDPD photo: adjusted brightness by DA Technical – shows braking tires into guard rail

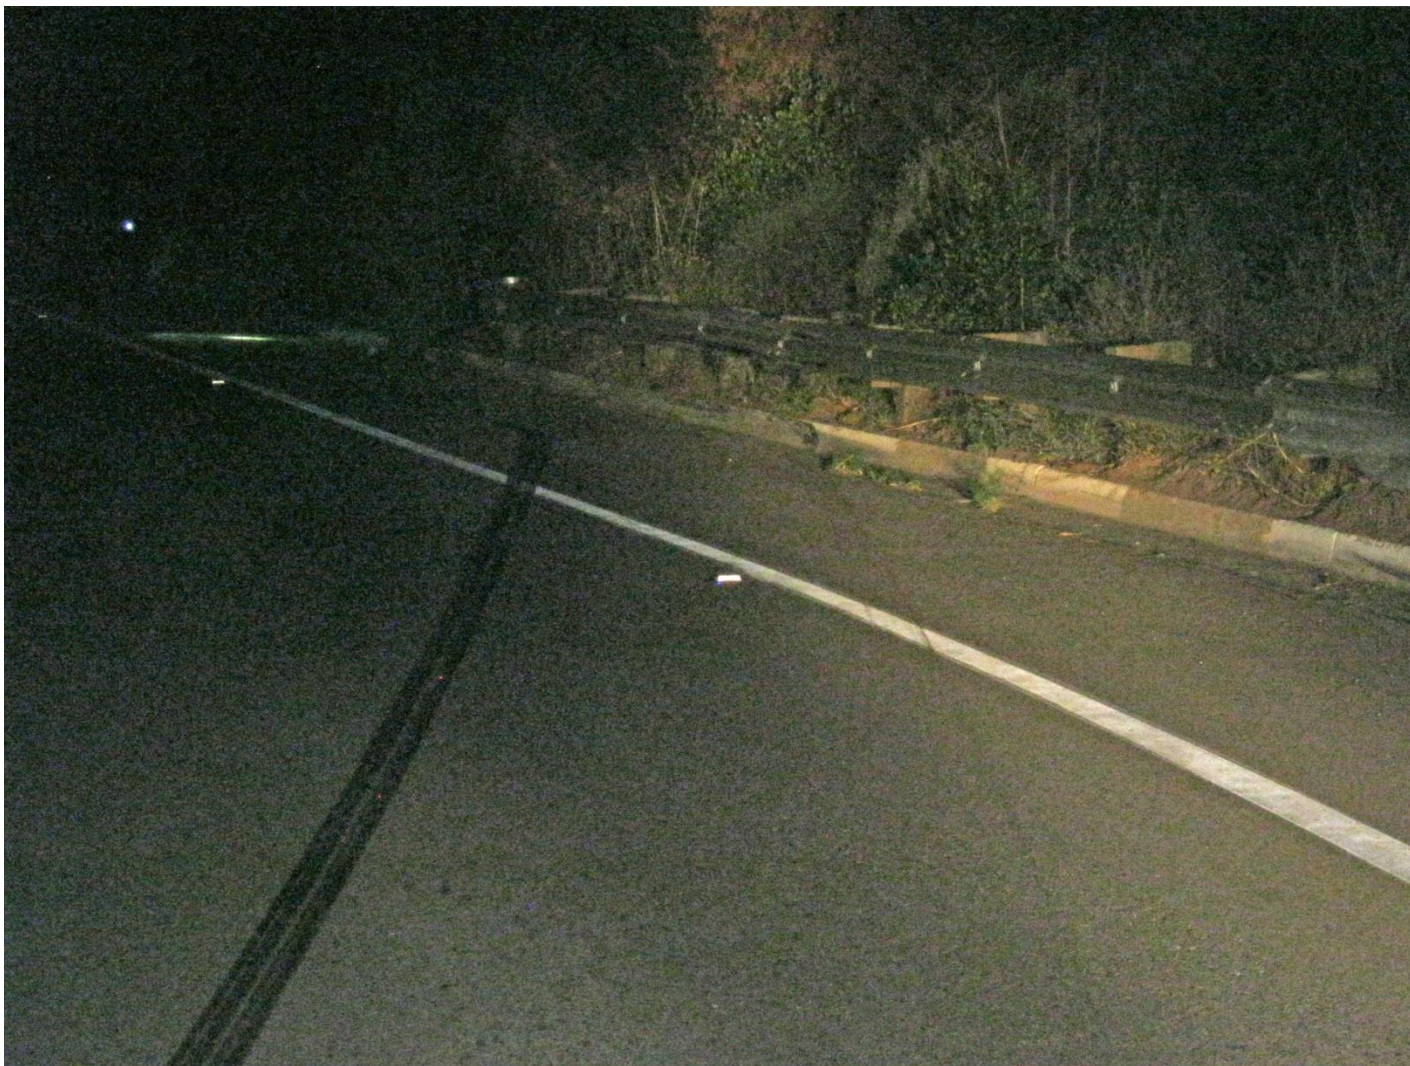
Left and right side skids into curb and guard rail

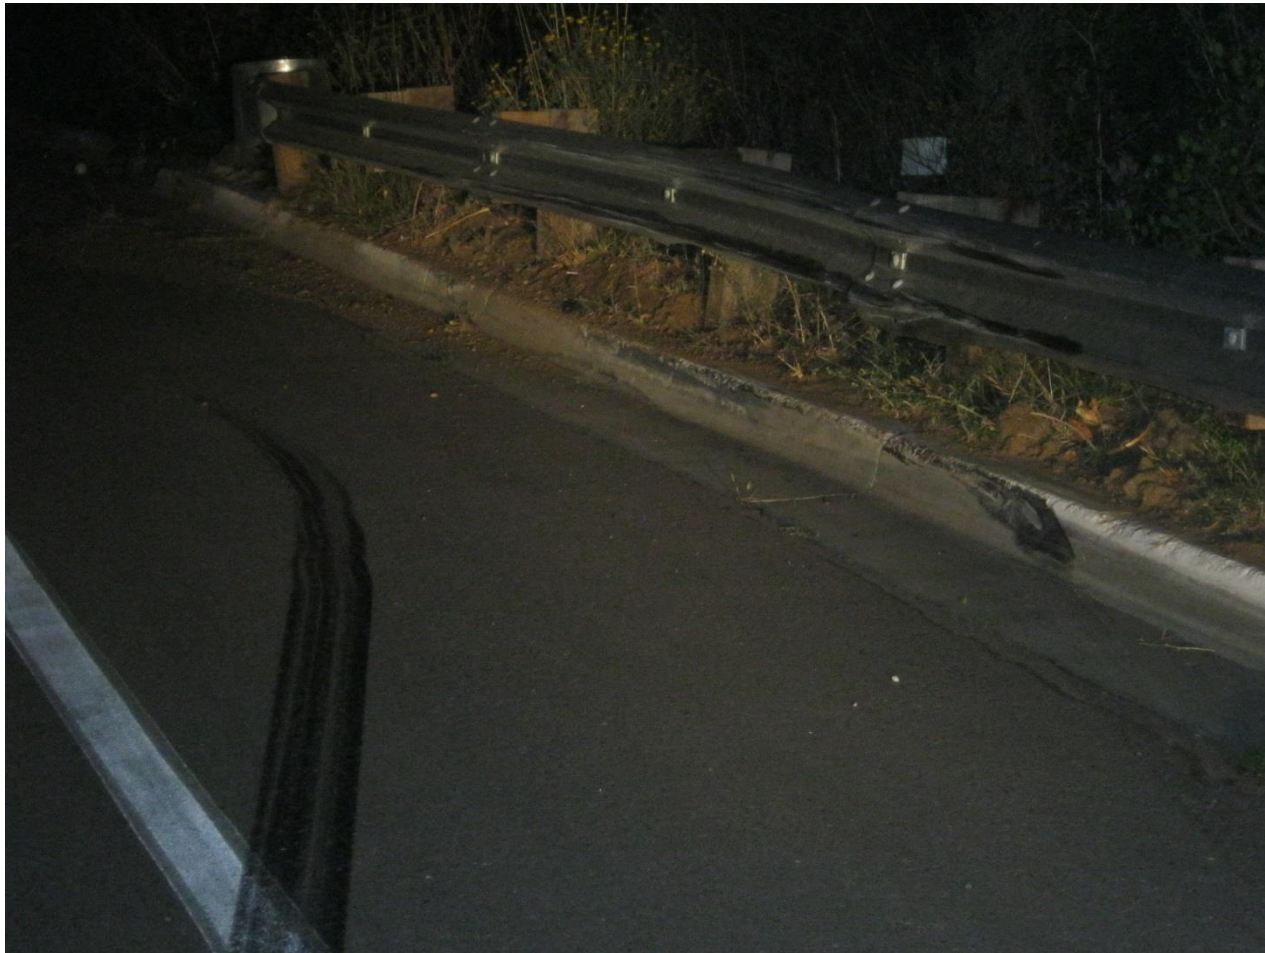
SDPD Image, Cady 2006 Mustang at location of rest

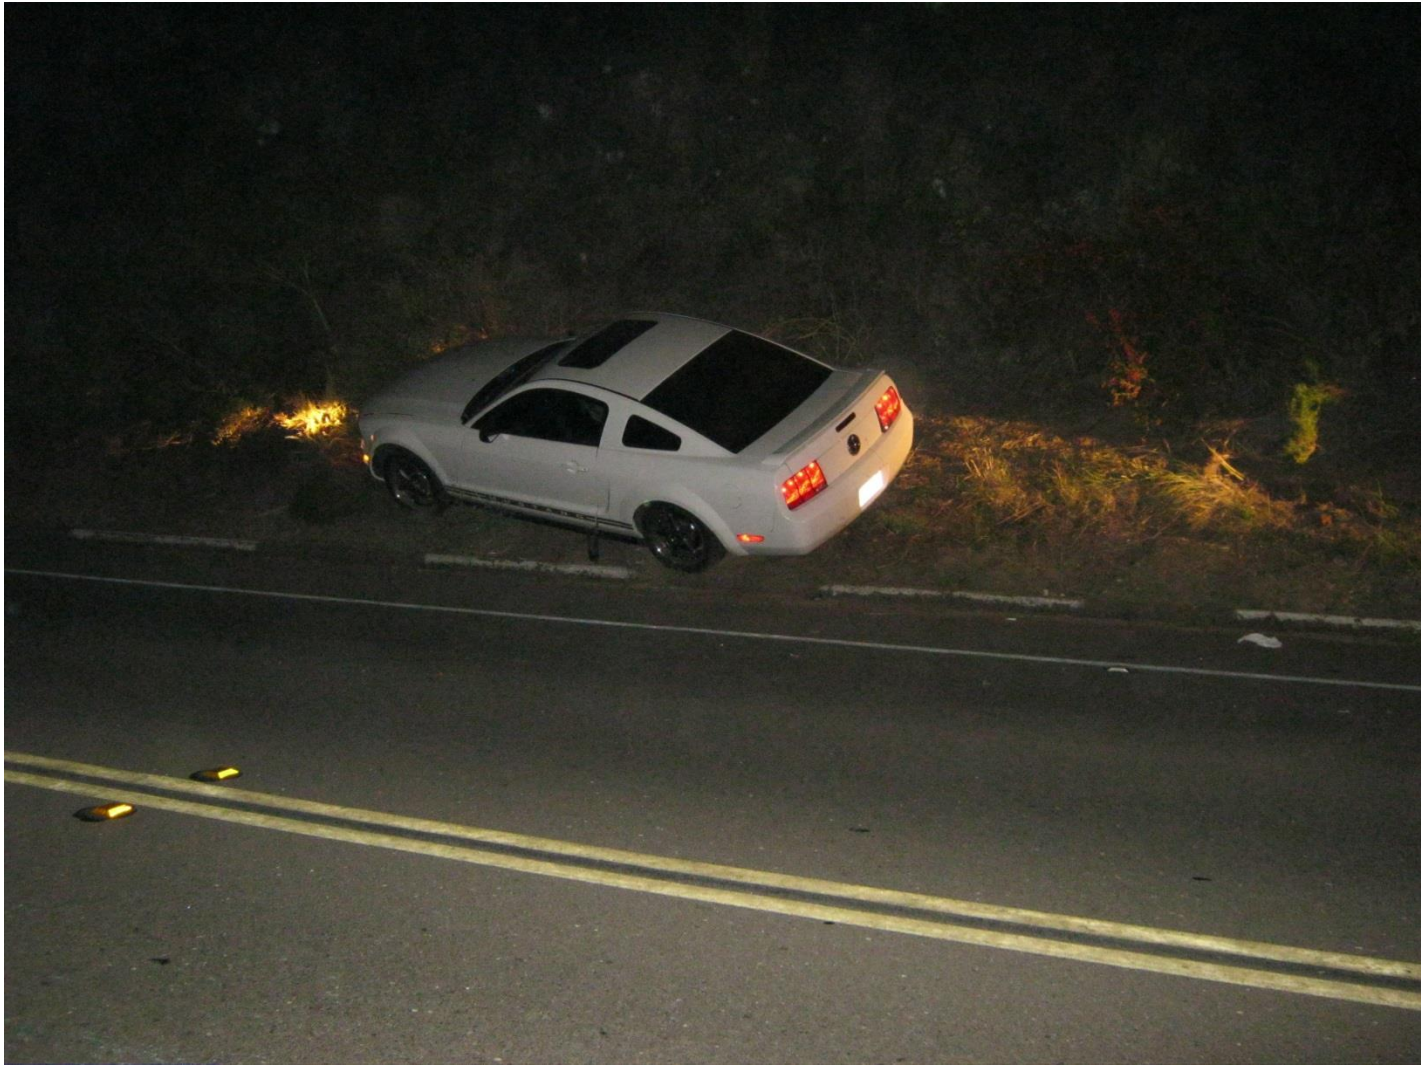
Cady 2006 Ford Mustang showing right side shearing damage with passenger side airbag deployment

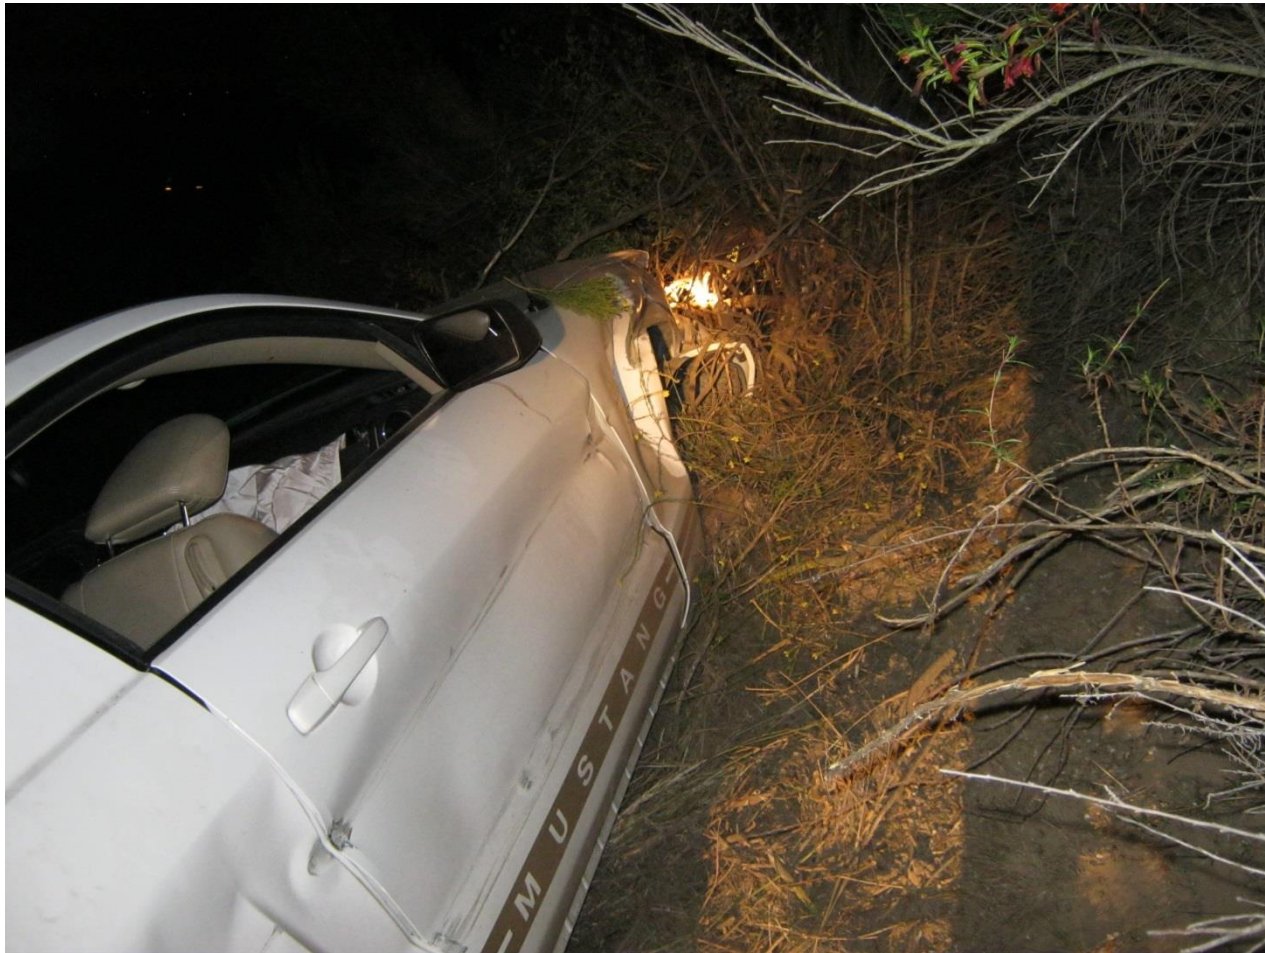
Travelers Insurance image Right front wheel damaged and deflated from impact with the guard rail and curb.

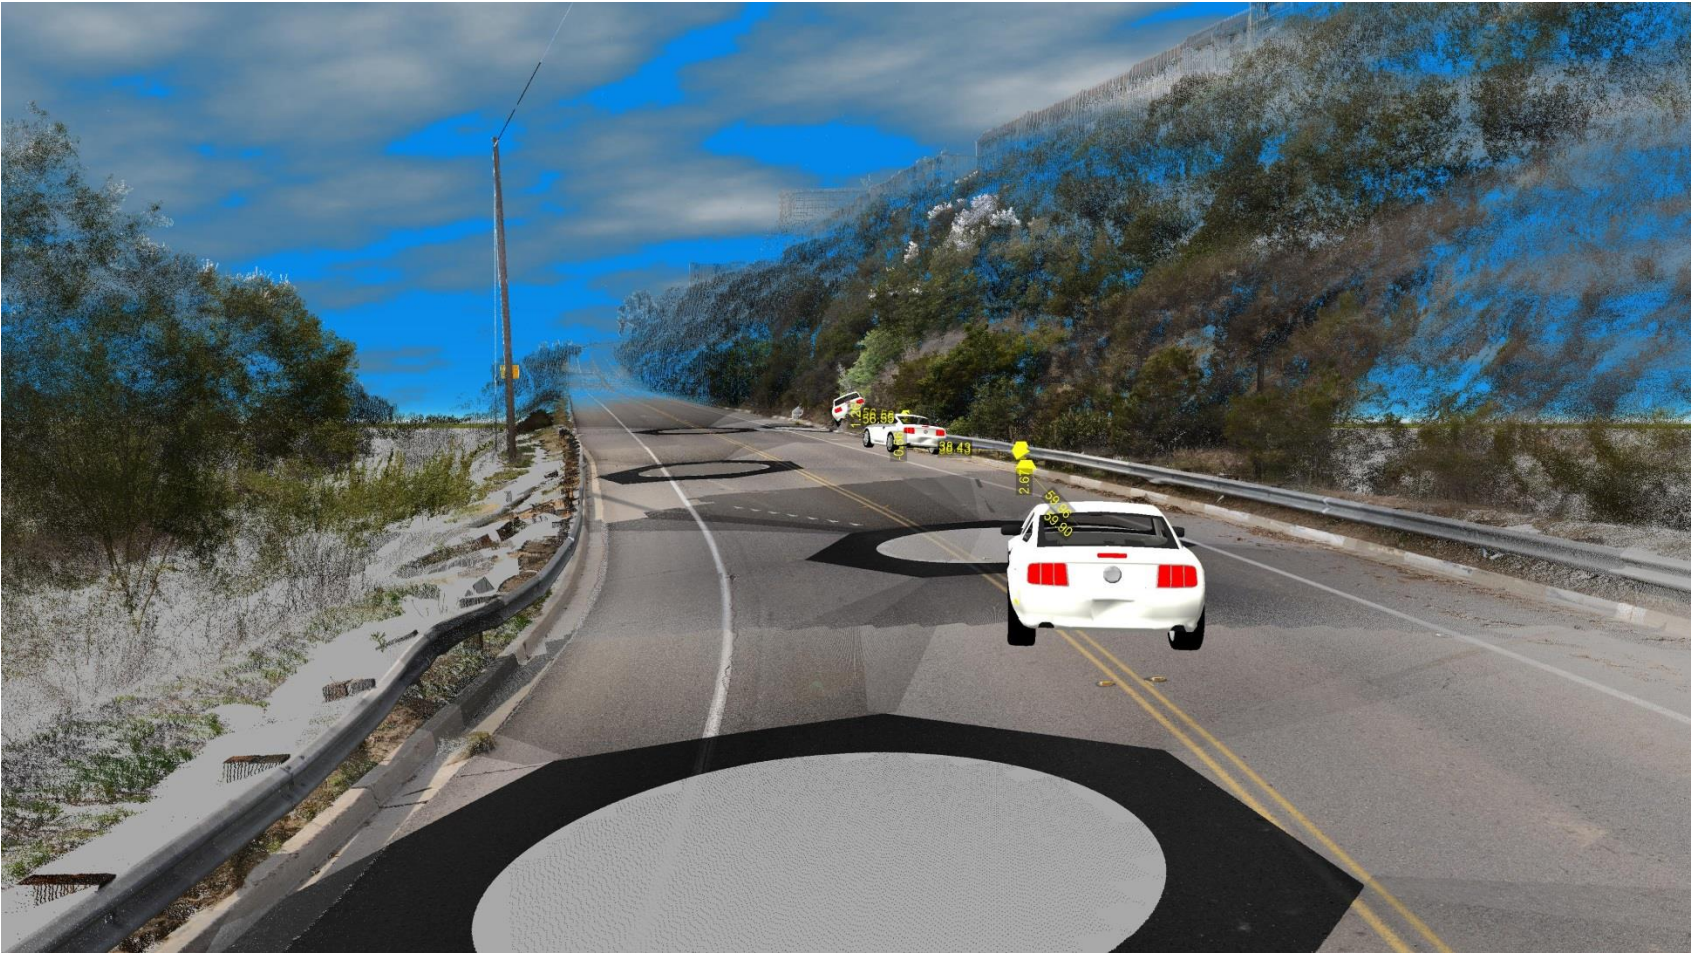
Edge FX screen capture showing the motion of an exemplar scale vehicle on the plotted tire mark deposits.

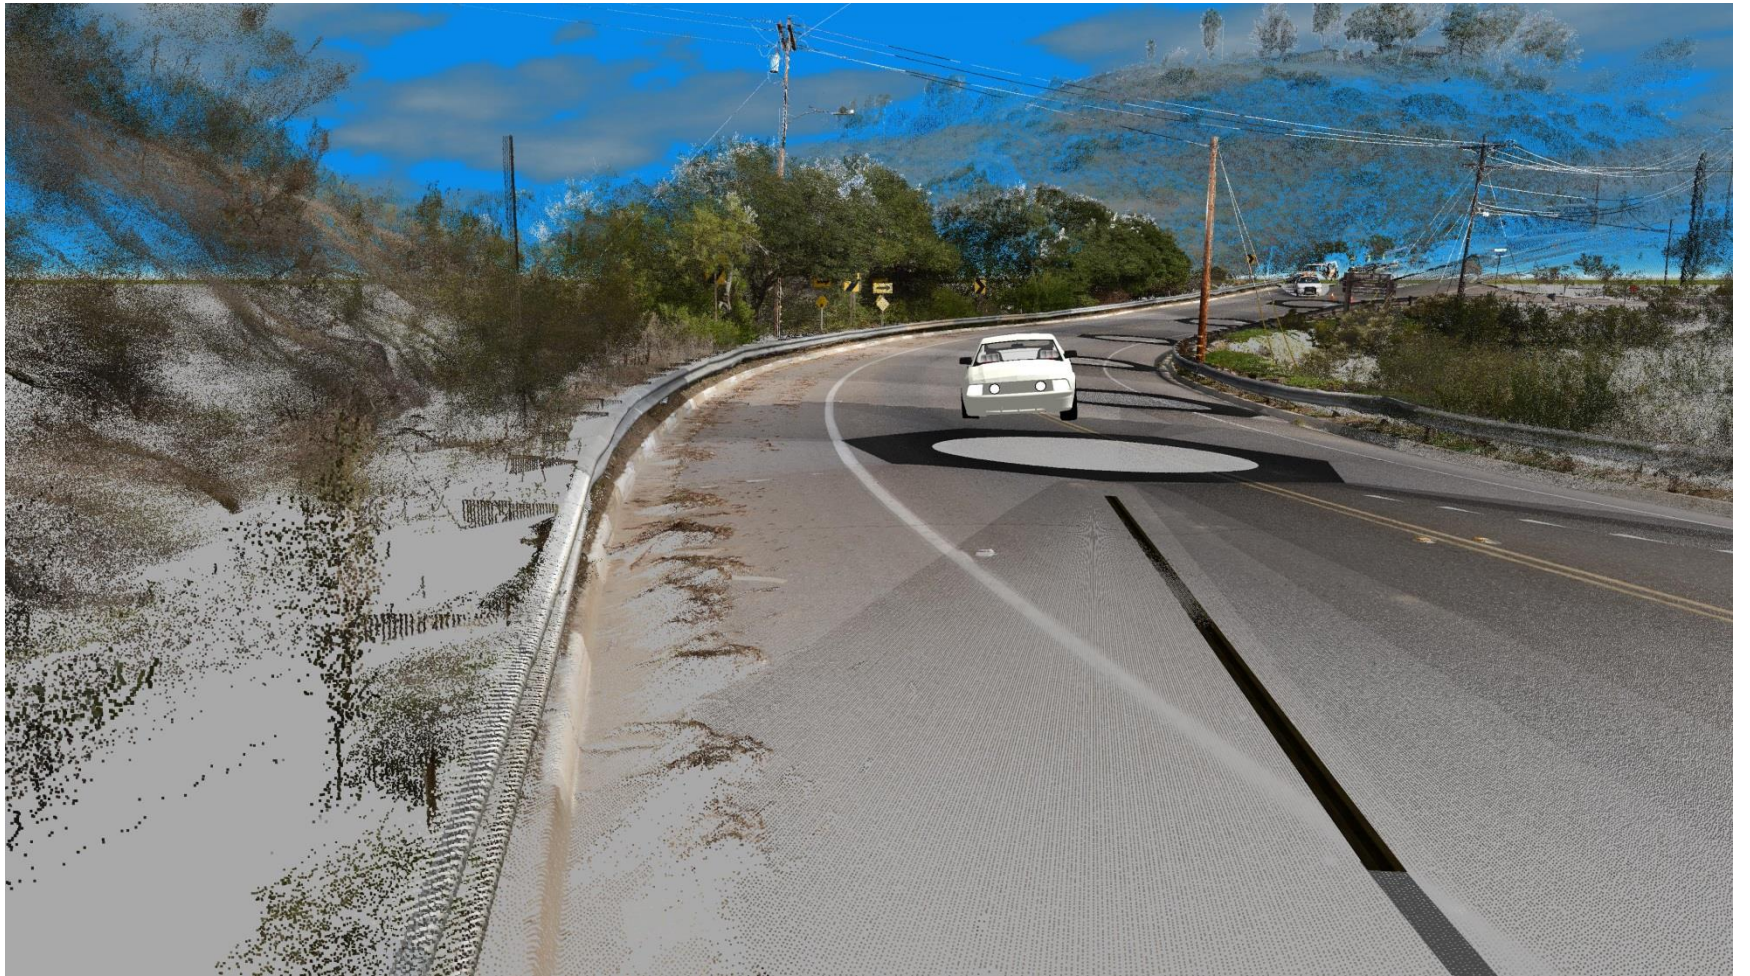
*RIEGL VZ-400* 3d laser scan point scale cloud model with exemplar on plotted tire mark deposit.

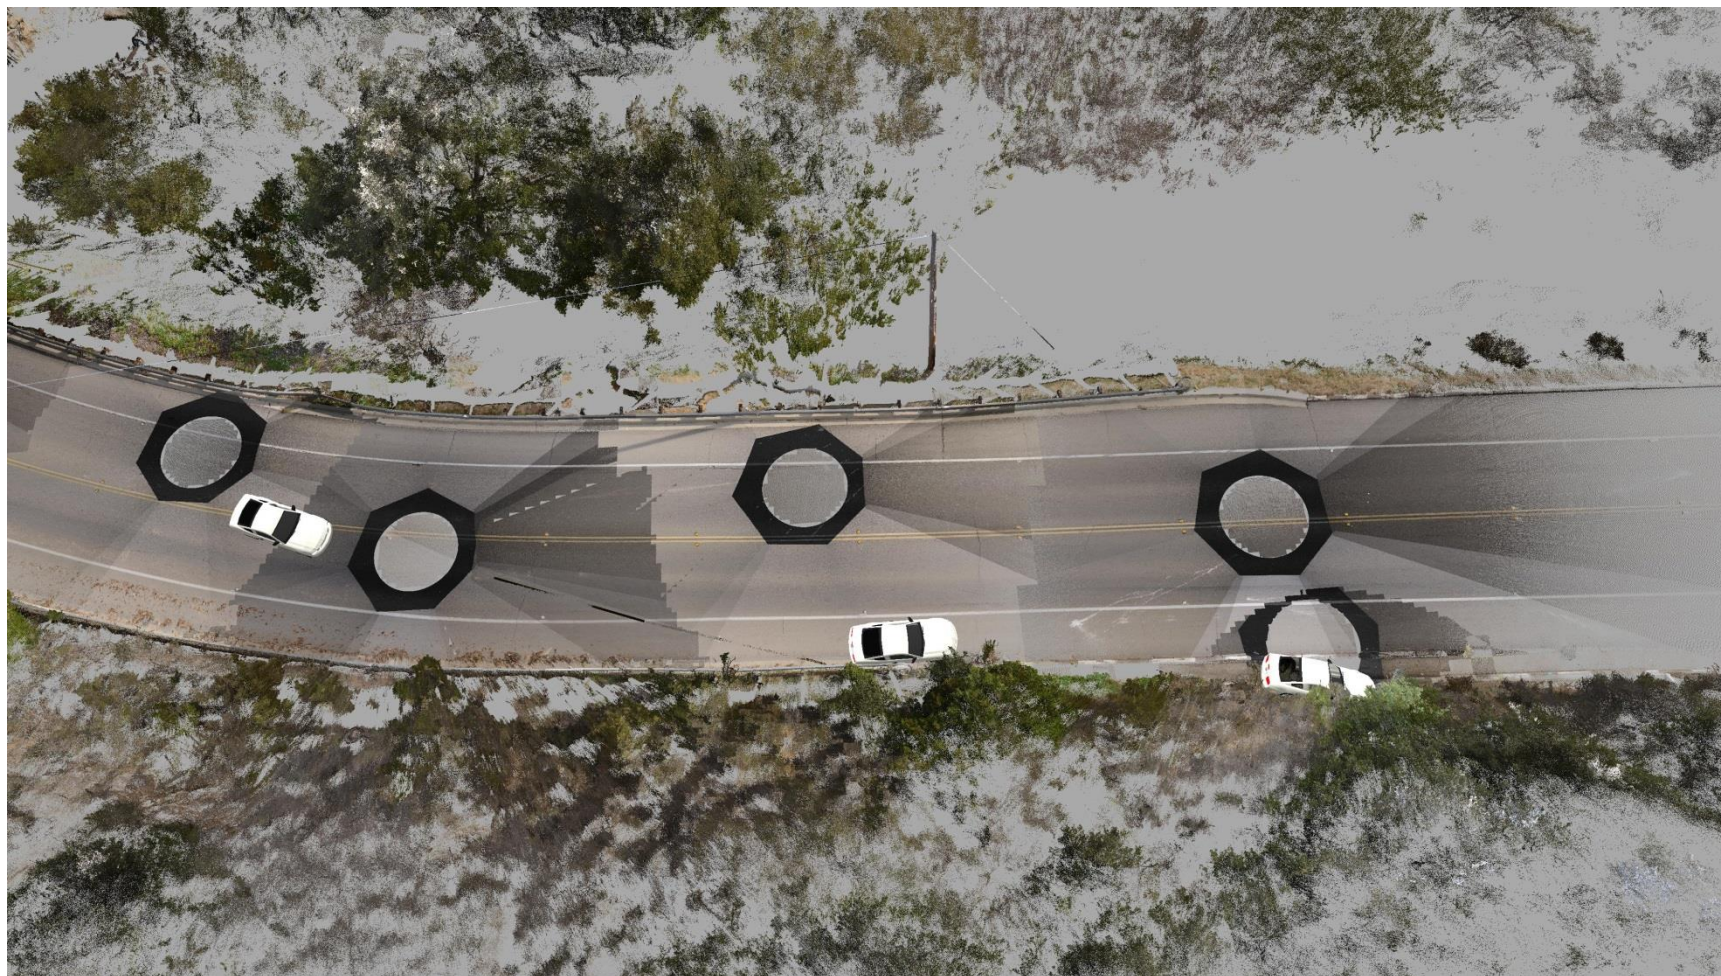
Overhead view of *RIEGL* VZ-400 3d laser scan scale model with exemplar and tire mark deposit approximating vehicle motion from subject collision.
