Crush Damage Profile 1 – subject vehicle scanned using Riegl VZ-400

Project: HYUNDAI EXEMPLAR  
Location: N 32°47'49.6856", E -116°57'43.1167"  
Date: 2015-04-30 12:52:37  
vehicle scan 04229015

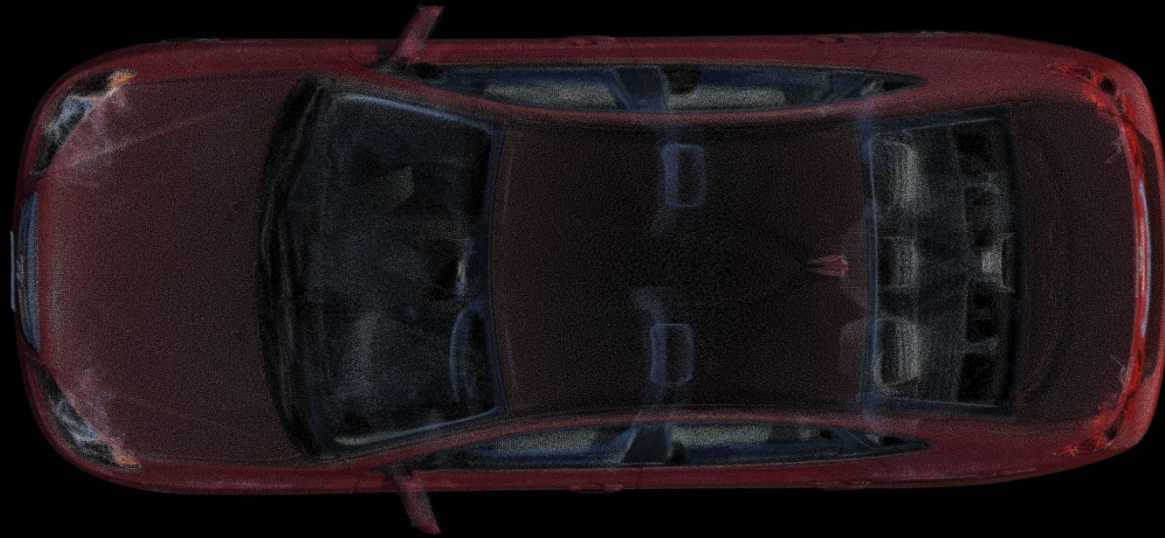
Exemplar vehicle scanned by Riegl VZ-400

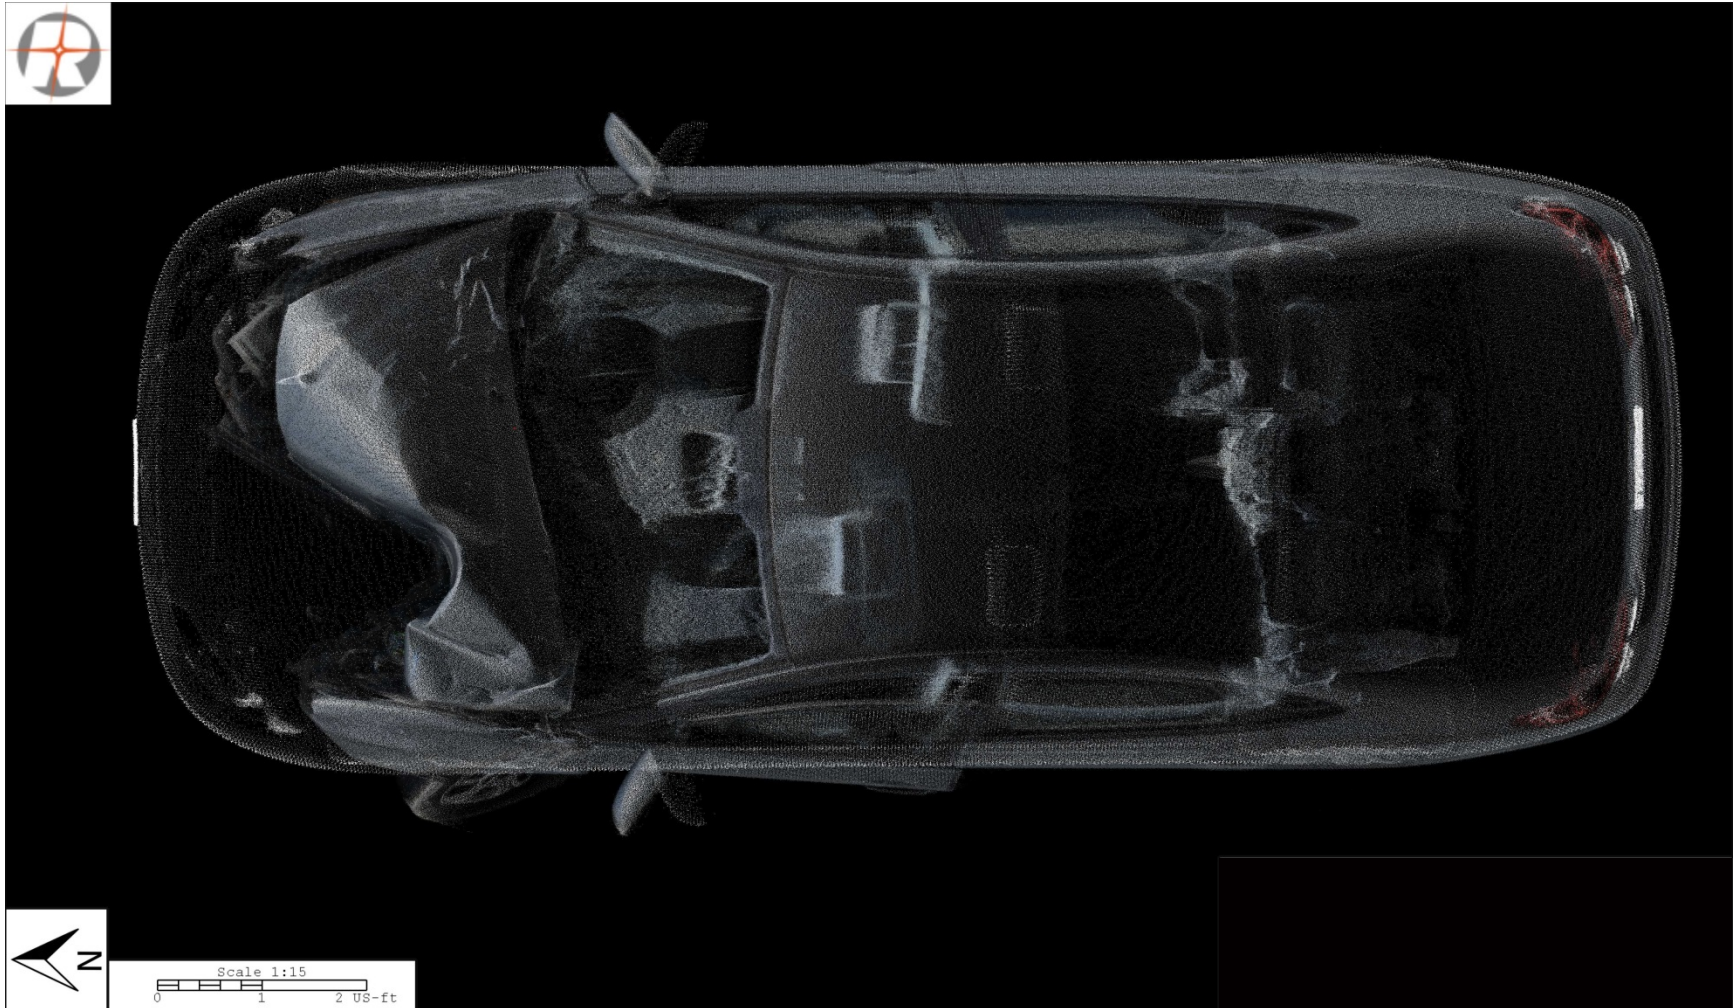
Subject vehicle overlaid on Exemplar in RiSolve to measure actual structural change.
