**People v William CADY**

**SCD No.253340 / DA No. ADP185**

**COLLISION: JUNE 09, 2012 2:58 A.M.**

**MT ACADIA BOULEVARD WEST OF SNEAD AVE.**

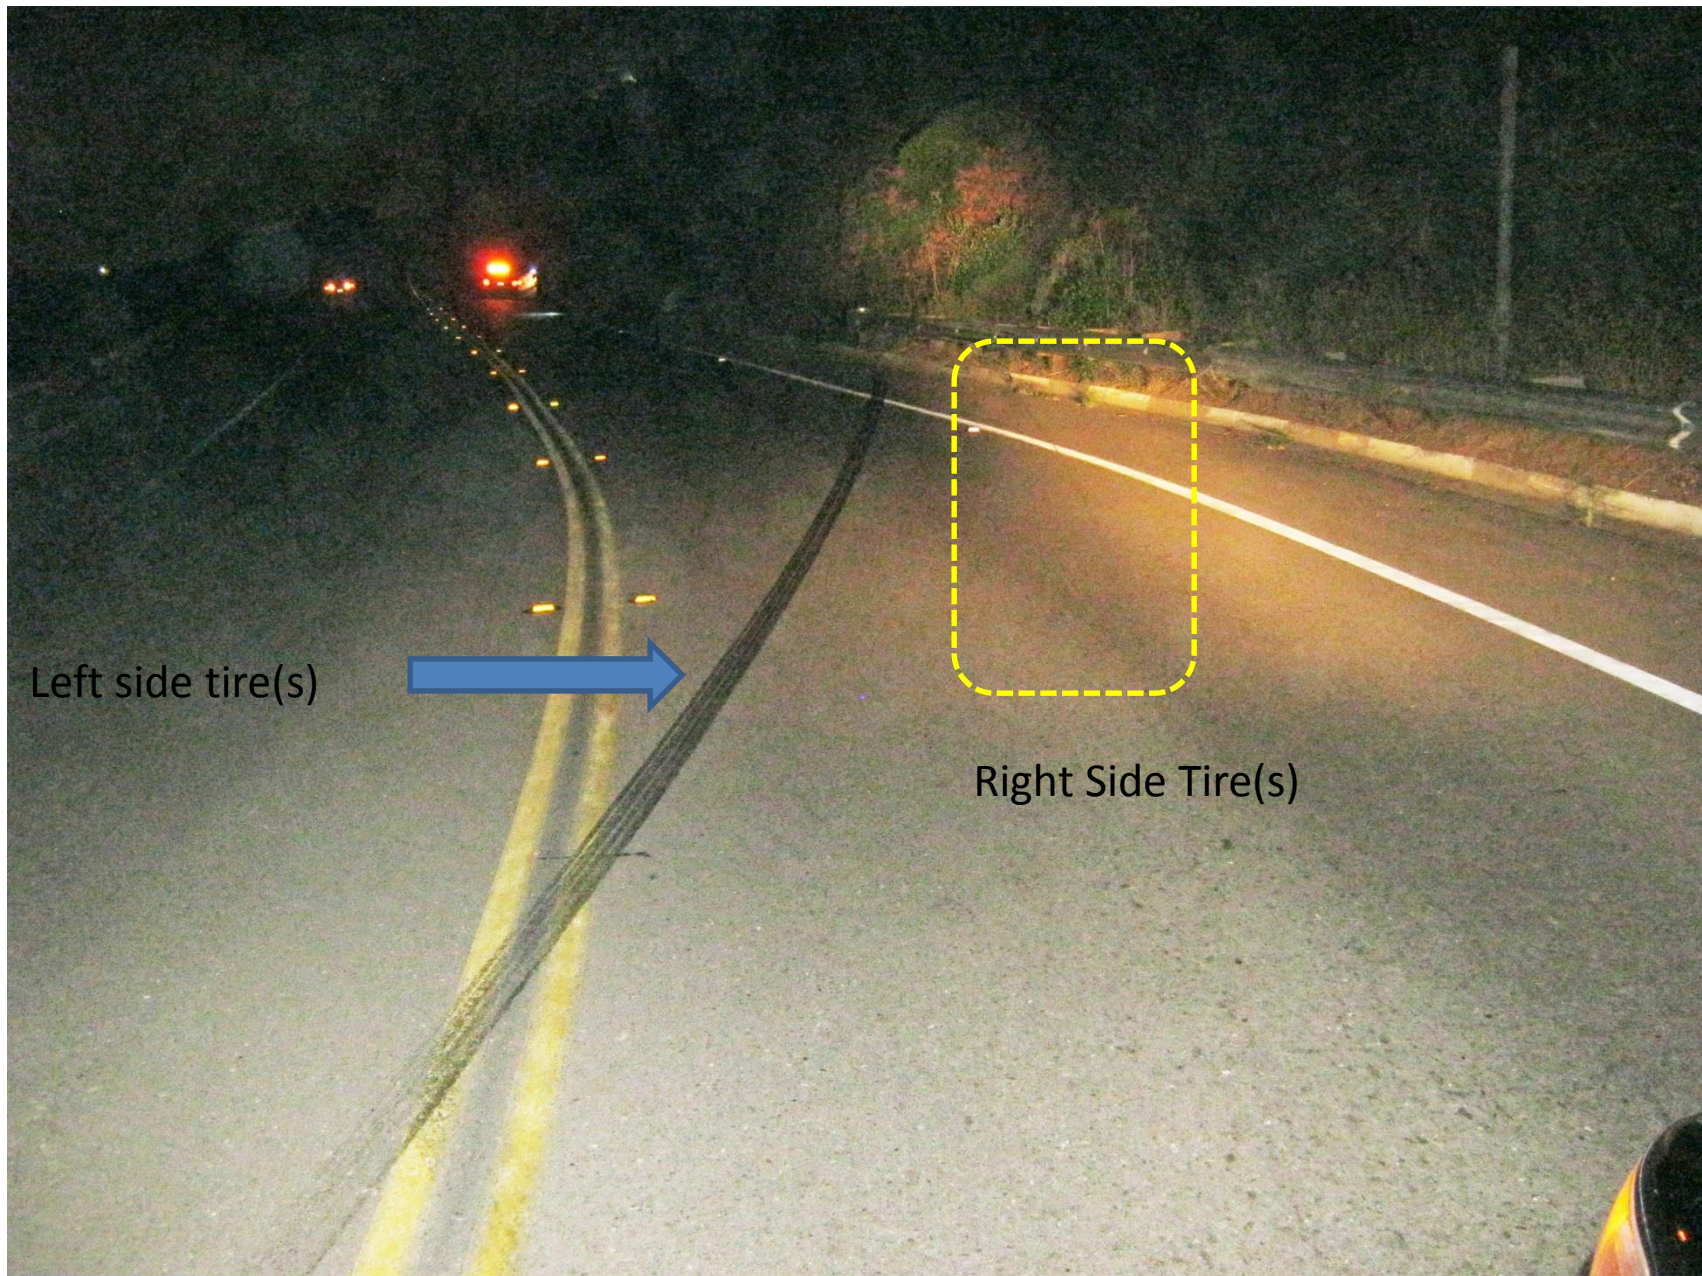
Left side tire(s)

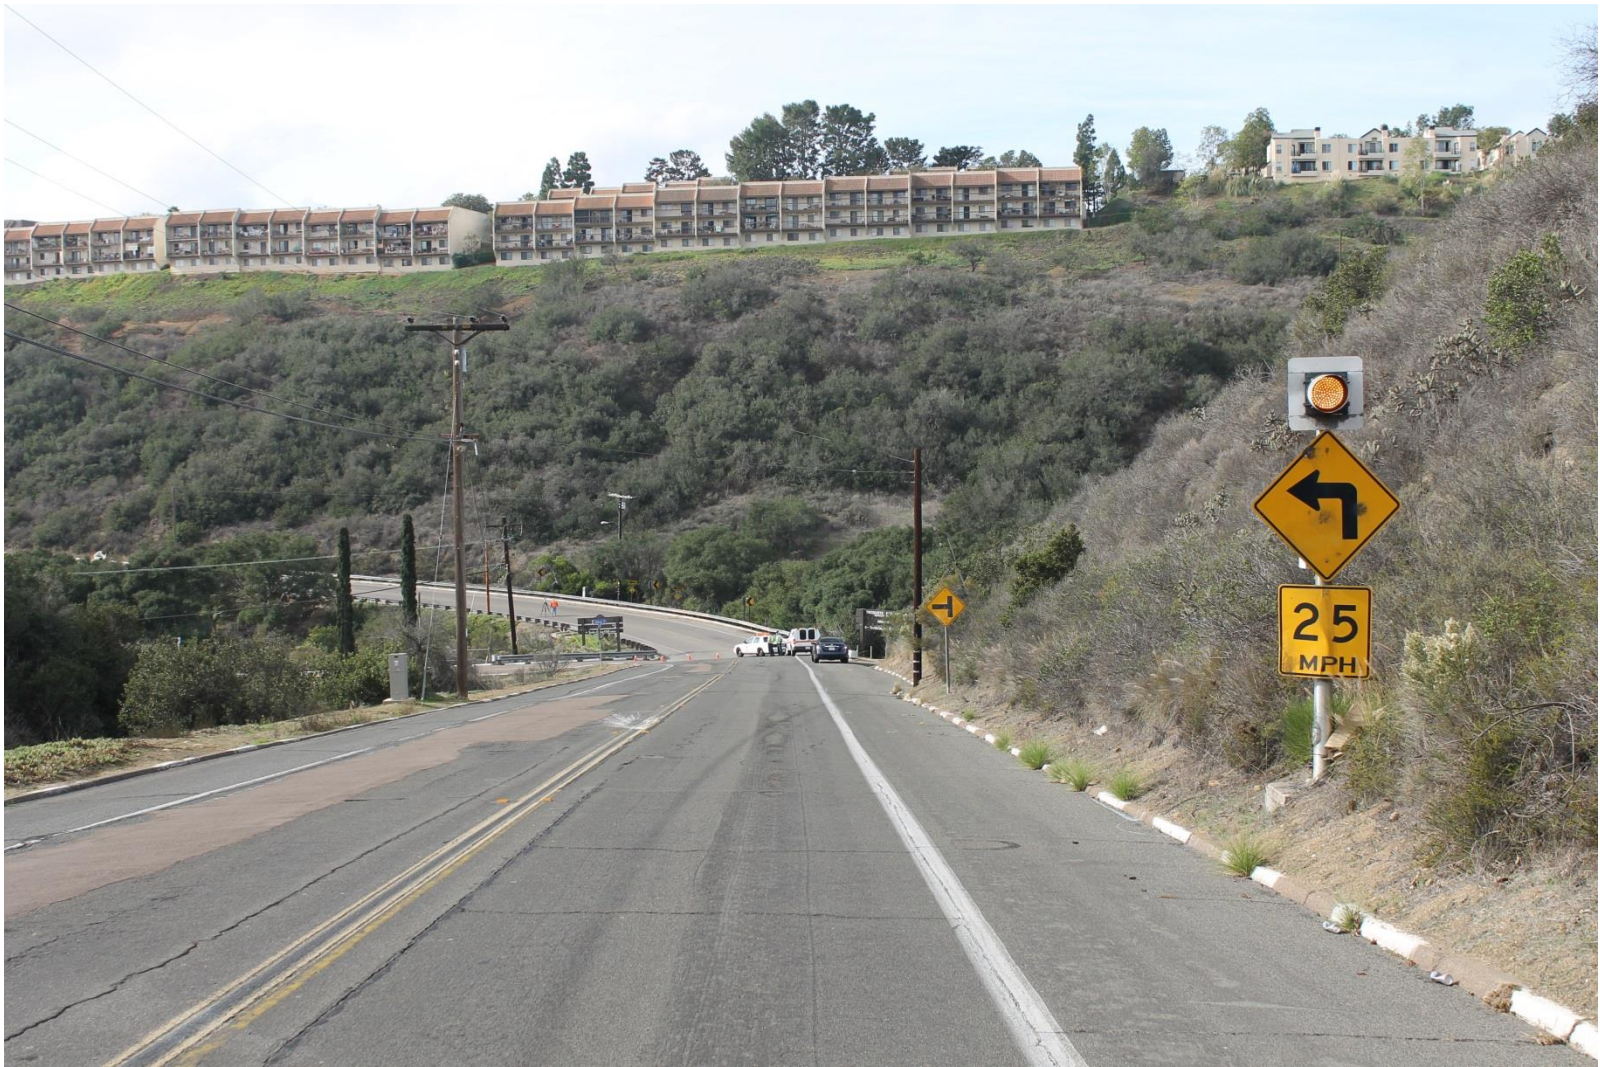
Flashing beacon on a post with a 25-MPH curve advisory sign (W13-1P) and left curve arrow (W1-1Left), with intersection warning sign to the west – these signs are east of Snead Ave.

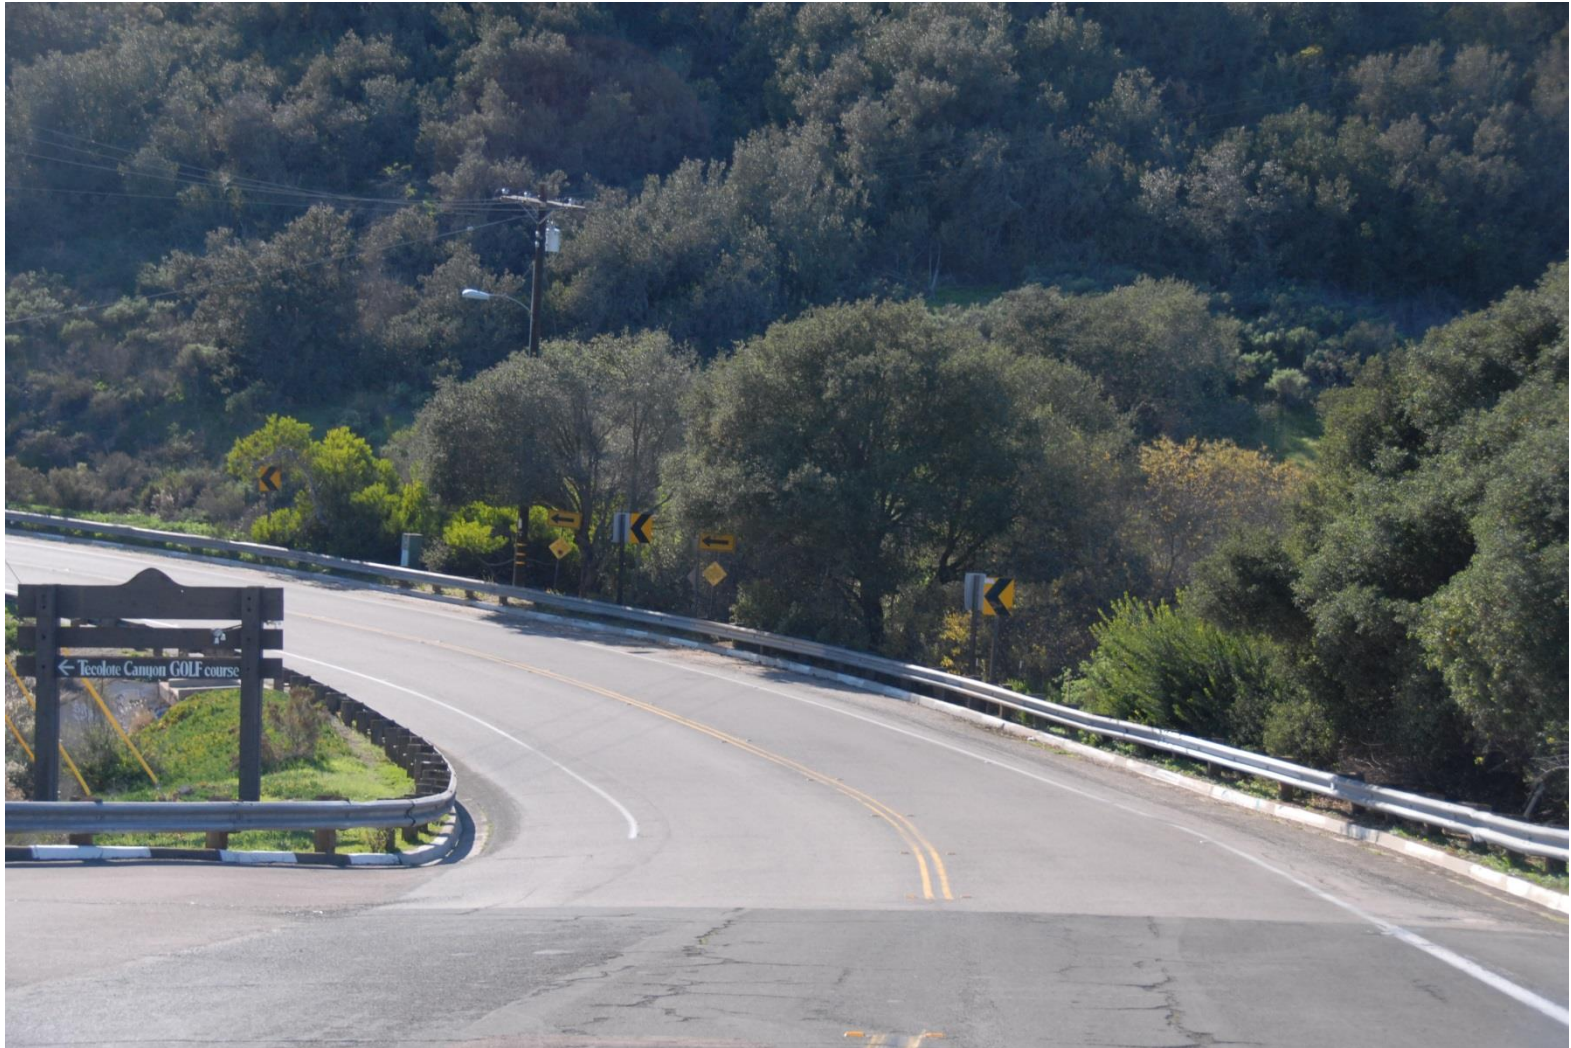
Additional advanced warning signs placed to alert drivers to the change in roadway geometry. Visible are three W1-8 Chevrons, with two W1-6 left Arrow signs mounted above two OM1-1 object markers. (EP 020215)

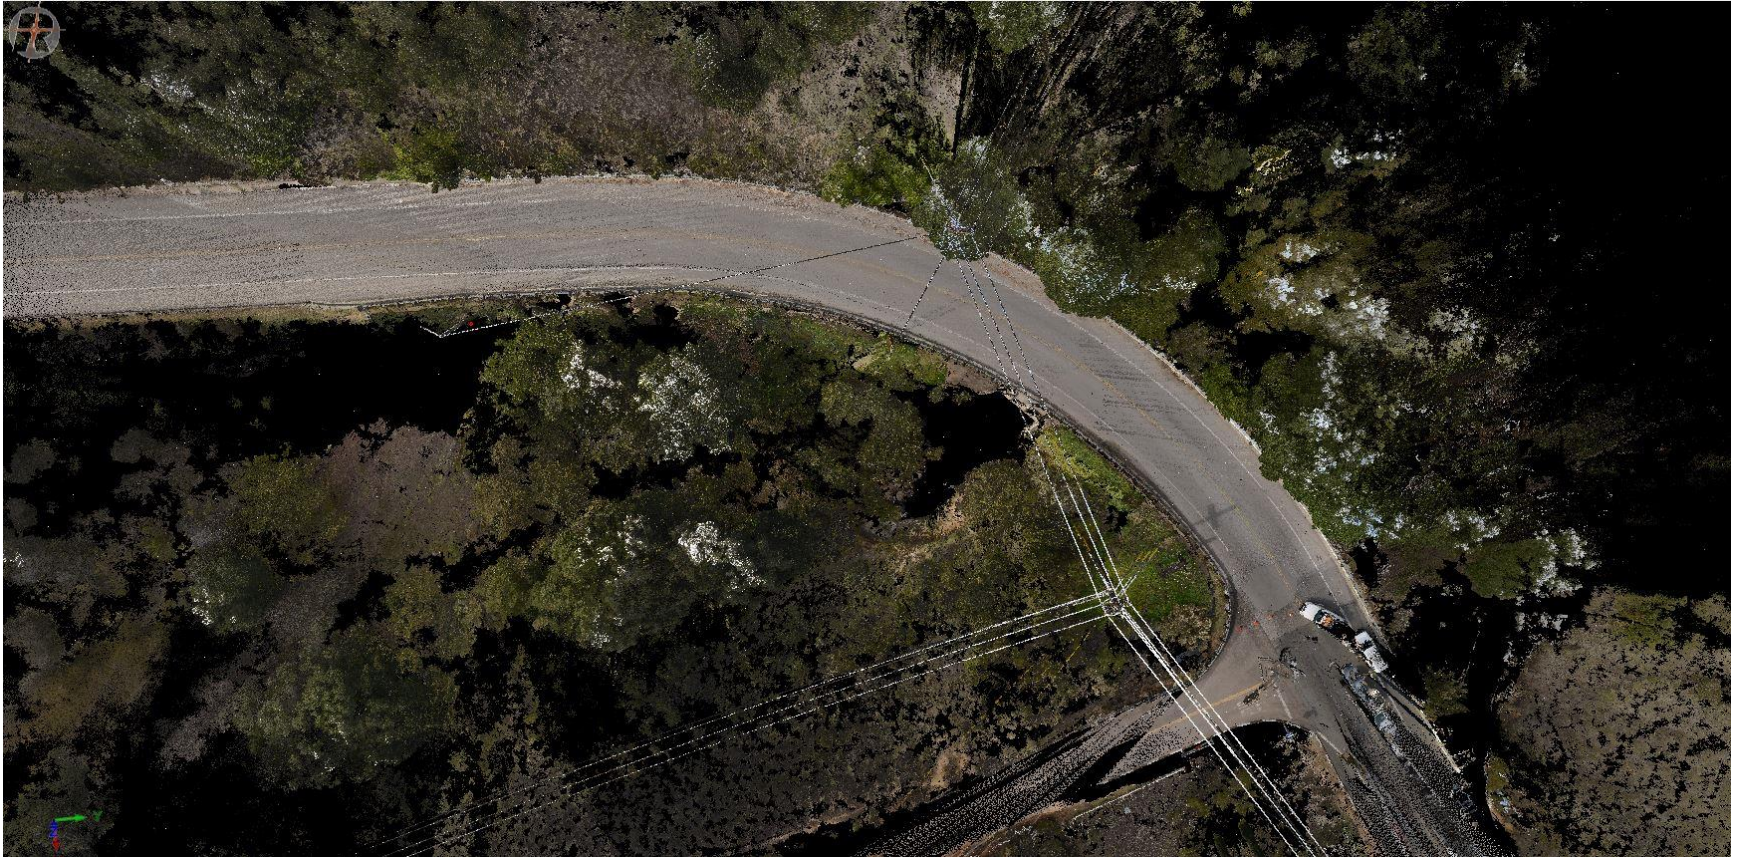
Additional curve warning signs (Chevrons) – 3d laser scan image, acquired by the *RIEGL VZ-400*
